STATE OF CALIFORNIA  
BUSINESS AND TRANSPORTATION AGENCY  
DEPARTMENT OF PUBLIC WORKS  
DIVISION OF HIGHWAYS

# AN EXPERIMENT USING EMULSIFIED ASPHALT COLD MIX AS A SURFACING MATERIAL

72-54

March 8, 1972

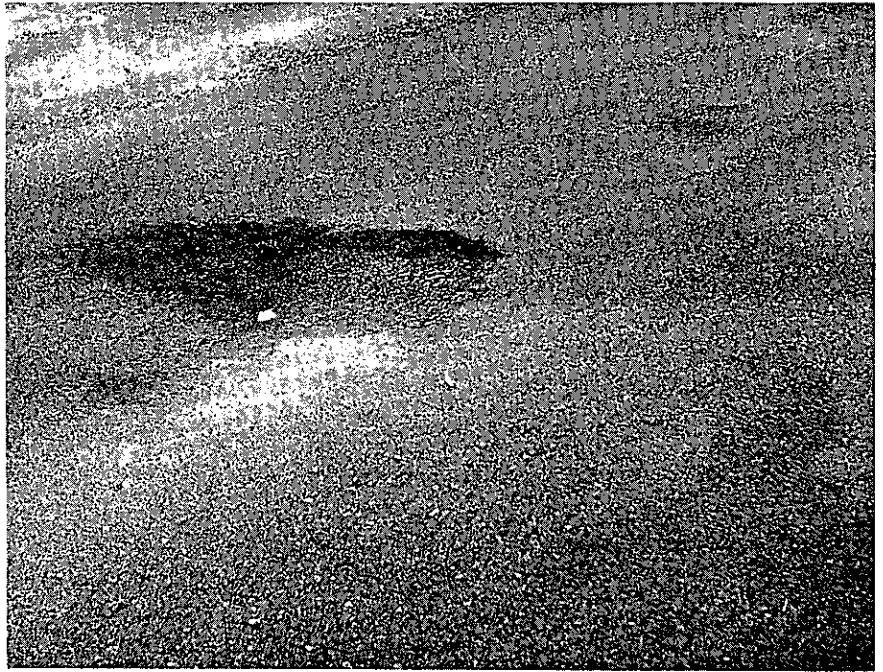
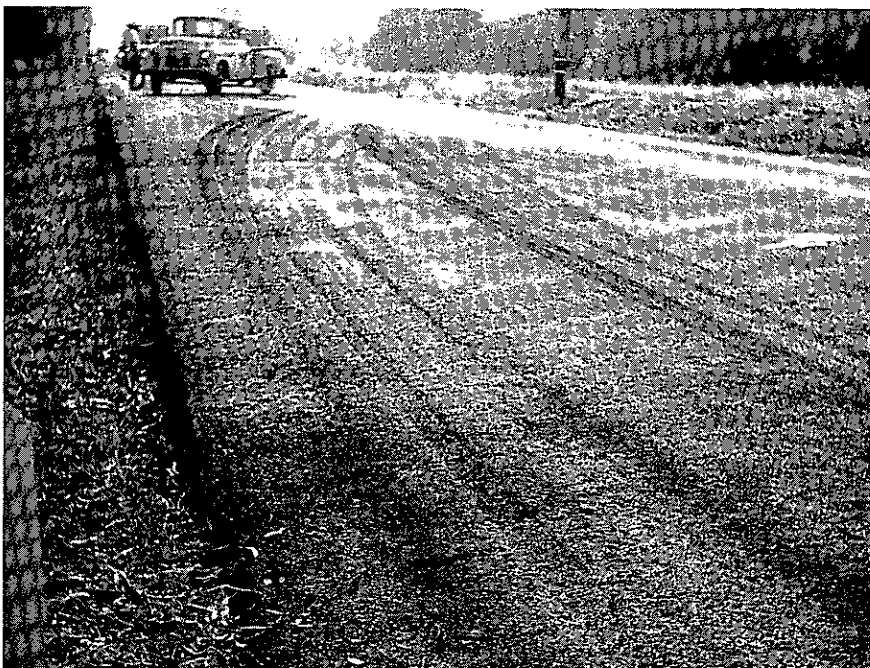
Traffic during paving was routed adjacent to the operation by a pilot car. Traffic was allowed on the first open graded section 45 minutes after placing. No visible rutting or distortion was apparent. Traffic was allowed on the dense gravel mixture in about 1 hour. Slight damage was noted in spots on the dense graded surface (Figure 9) where traffic had to turn across the lanes to avoid construction.

**Figure 9**  
**RAVELING IN DENSE**  
**GRADED DUE TO**  
**TURNING (4 HR.)**

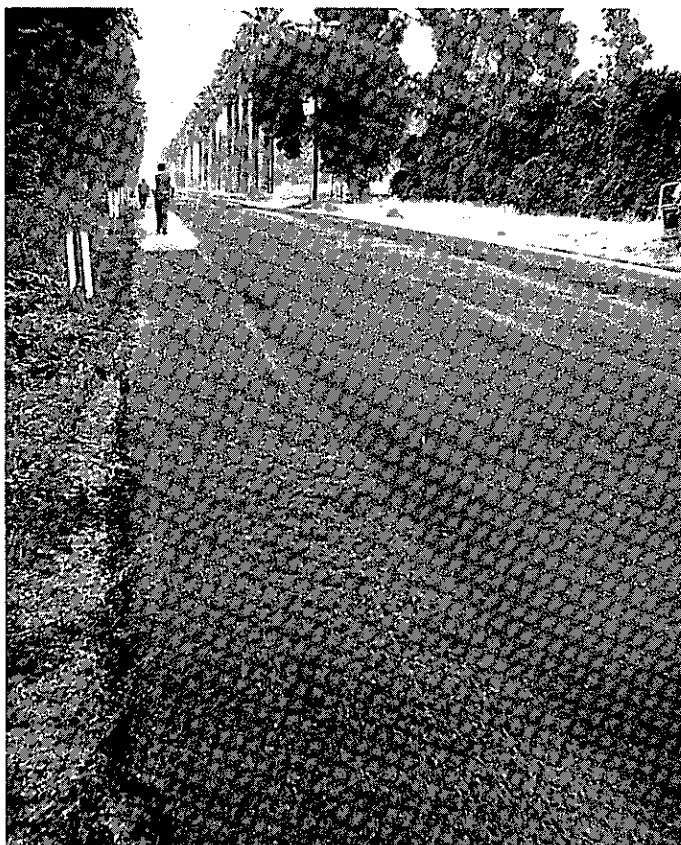
There was also some visual evidence that the mixture had not cured completely. For example, a 2-foot section near each edge of the pavement appeared brownish compared to the rest of the pavement, which indicated the asphalt still was emulsified (Figure 10). The wheel track areas appeared black and cured; however, this apparently was only the surface and not indicative of the full depth. The fact that this area was not sufficiently cured in depth was confirmed a few hours later when a fog seal was applied consisting of CSS-1h emulsion diluted 3:1 and applied to obtain a theoretical 0.10 gal. per sq. yd. residue. Traffic was allowed immediately over the sealed area and as the emulsion in the fog seal began to break, it stuck to both tires and surfacing. The result was serious tearing and raveling of the surface (Figure 11). Rocks ripped from the surface were being thrown by the tires of fast moving traffic creating a hazard. Sand was immediately brought out and placed on the surface to blot the emulsion. This was successful and additional raveling and tearing of the surface was arrested.

Figure 10  
JUST PRIOR TO FOG SEAL,  
NOTE CONTRAST BETWEEN  
SHOULDER & TRAVEL WAY,  
INDICATING INSUFFICIENT  
CURE

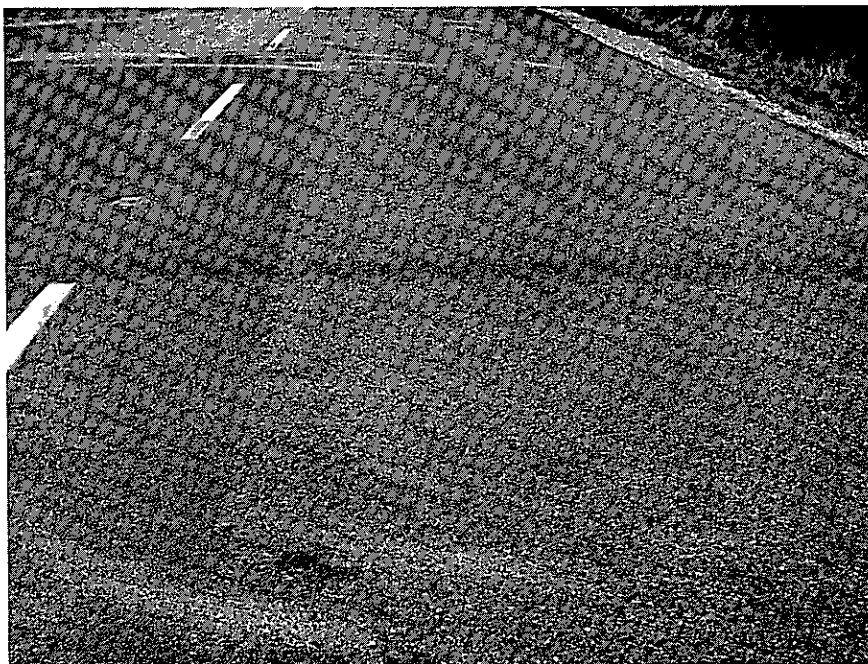
The dense graded mixture in an area where the fog seal was not applied had substantial surface raveling (Figure 12). The area of dense graded mix with the fog seal also appears to have extensive surface raveling (Figure 13); however, it is difficult to estimate whether it has increased in severity from the original raveling caused by the early seal coat. District personnel feel there has been some progression of the surface scuffing or raveling since it first occurred.

It can be seen that the dense graded mix, without a fog seal, and the open graded mix have the same skid resistance; however, the dense graded surface, without a seal was badly ravelled at the time of testing (Figure 12). This ravelling would not be acceptable and fog seals, which reduce the skid resistance, are necessary.

Figure 12  
RAVELING IN  
DENSE GRADED  
(NO FOG SEAL)  
(90 DAYS)

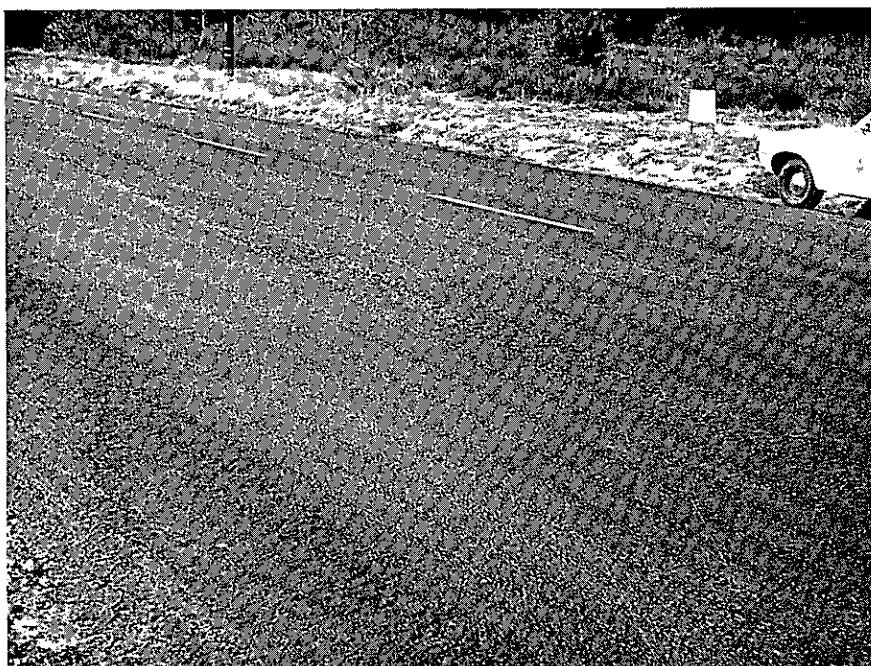
Figure 13  
RAVELING IN  
DENSE GRADED  
(WITH FOG SEAL)

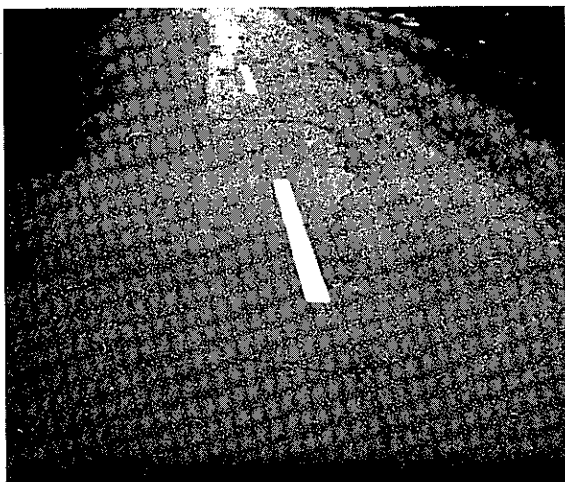
The open graded mixture had not deteriorated greatly from the initial observations. It is evident, however, that a few rocks are still being displaced and a few areas in the wheel track are definitely beginning to indicate a raveling pattern. Hairline cracks are now becoming easily distinguishable and are an indication of reflection cracking (Figure 14).

**Figure 14**  
**REFLECTION CRACKS**  
**IN OPEN GRADED**  
**(90 DAYS)**

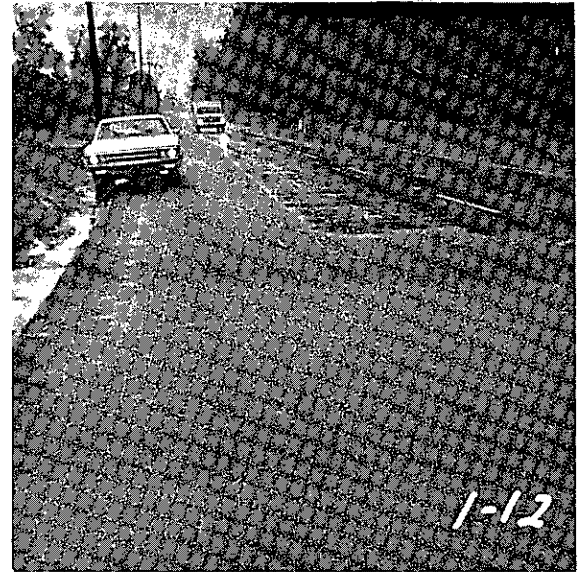
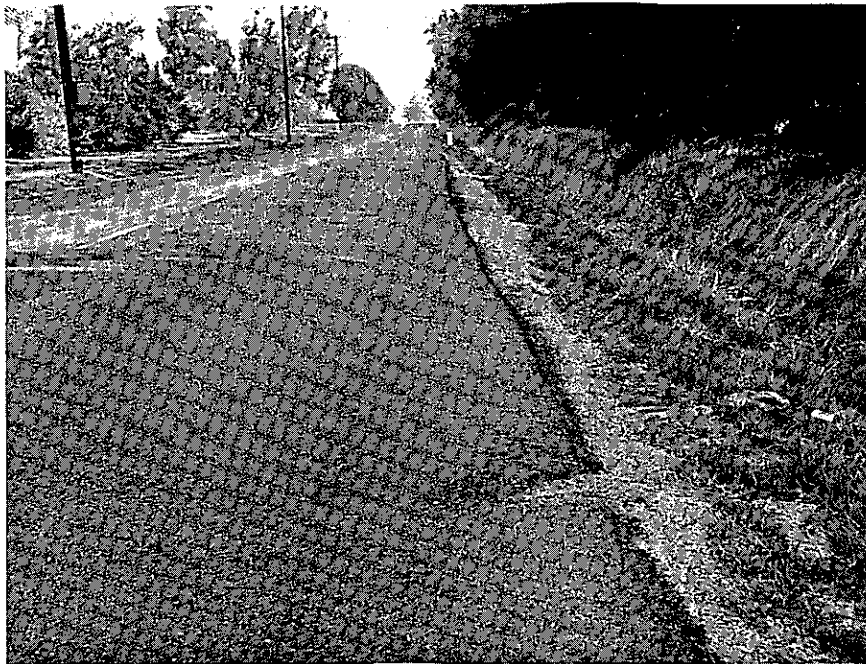
Figure 17  
FRIABLE SHOULDER  
DUE TO LACK OF  
COMPACTION

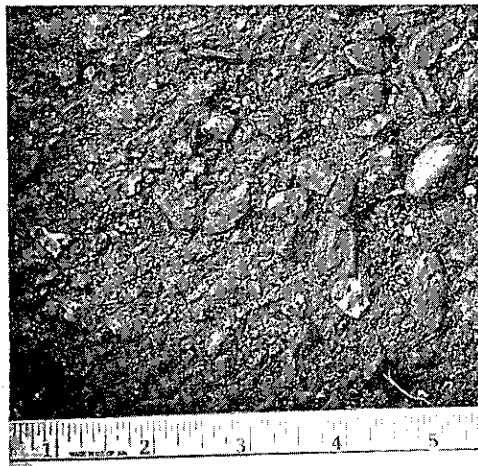
**AFTER 24 HRS. TRAFFIC  
(BEFORE FOG SEAL)  
(3)**

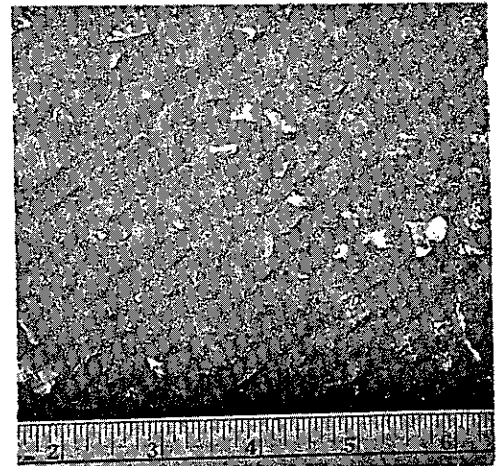
**AFTER 90 DAYS  
(4)**

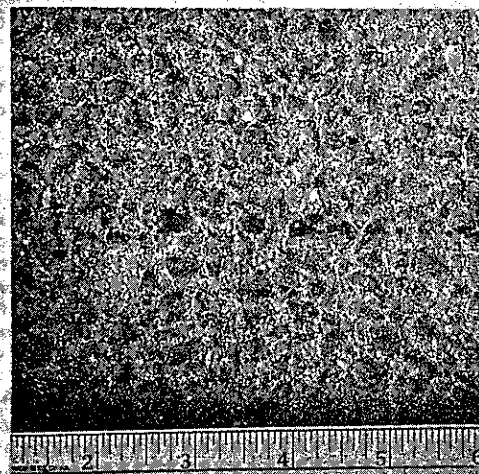
The first section of open graded mixture had noticeable surface raveling. Subsequent sections of this mixture showed less severe raveling. It was felt that the raveling in the first section was due, at least in part, to placing the sand choker too early, thus retarding the curing which resulted in a lack of surface cohesion and manifested itself by raveling under traffic. Raveling was generally confined to the wheel track areas.

24 HRS. OF TRAFFIC  
(5)
